Coal Mine Fatal Accident 2003-25-26

Operator:	Progress Coal (Massey Energy Company)
Mine:	Twilight MTR Surface Mine
Accident Date:	September 17, 2003
Classification:	Powered Haulage
Location:	District 4, Boone County, WV
Mine Type:	Surface
Employment:	153
Production	19,000 tons/day

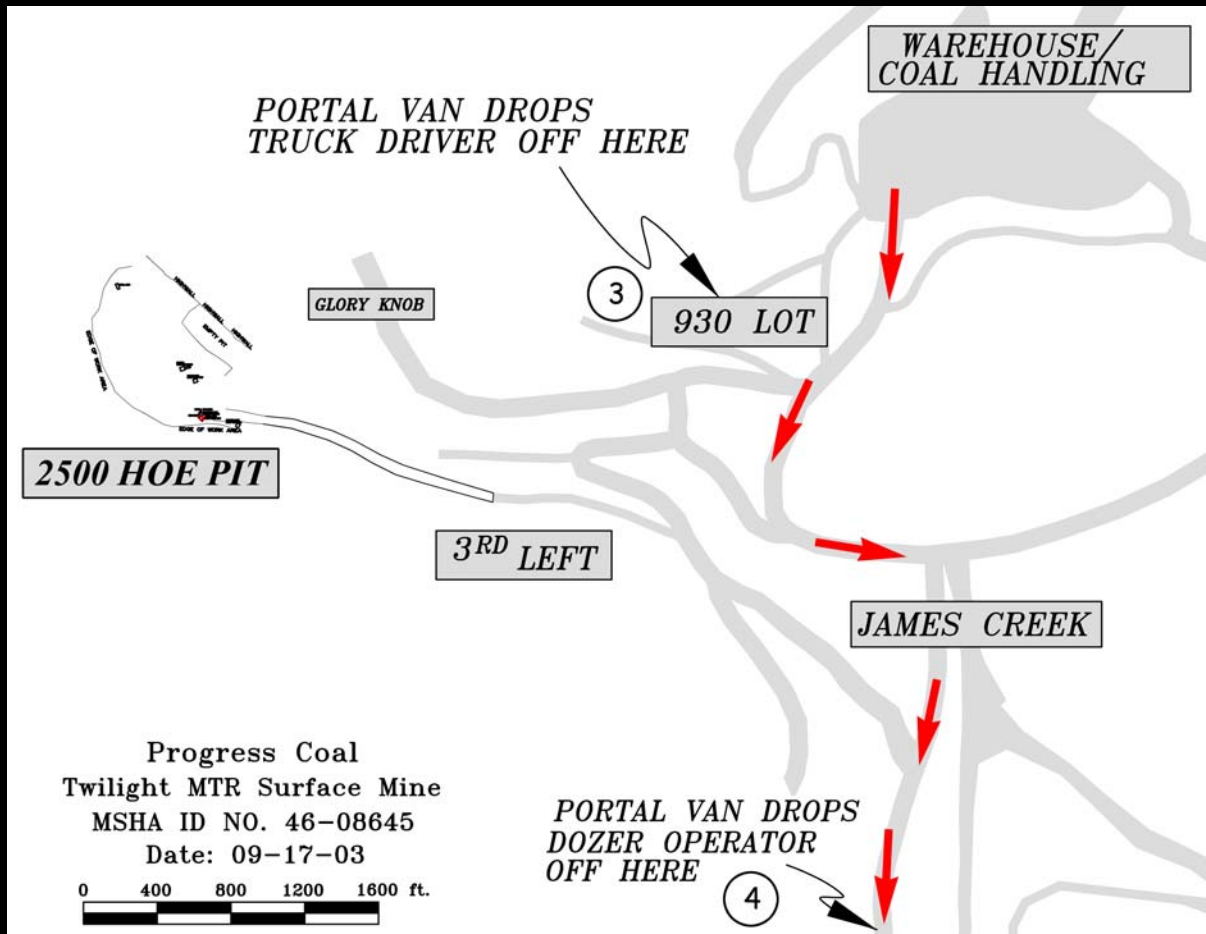
3. The back-hoe operator then drove the portal van ~400-500 feet from the warehouse, where he dropped off the rock truck driver at his truck.
4. Next, they dropped off one of the dozer operators on James Creek Road.

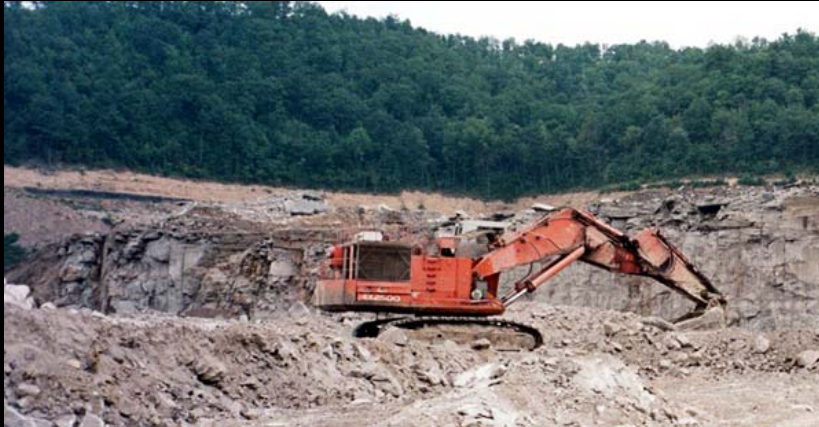
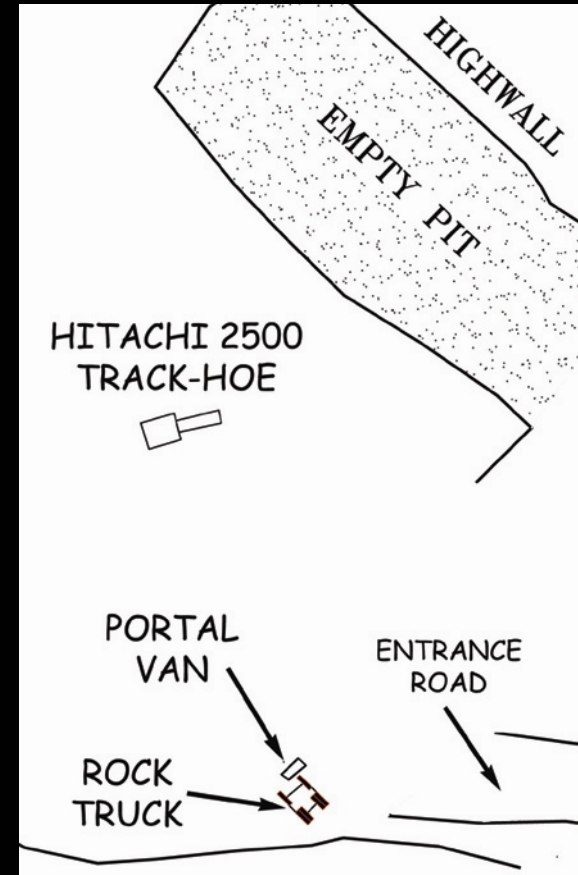
- Meanwhile, the rock truck driver who requested the supplies had left the parking area and traveled to the 2500 Hoe Pit, stopping approximately 270 feet away from the Hitachi Model 2500 Track-hoe.
- Also at this time, a mechanic finished servicing the track-hoe and left its dome lights and small entrance lights illuminated as he left the pit.

- As the portal van approached to within ~50-60 yards of the truck, the van driver radioed a message for the truck driver to get his supplies.

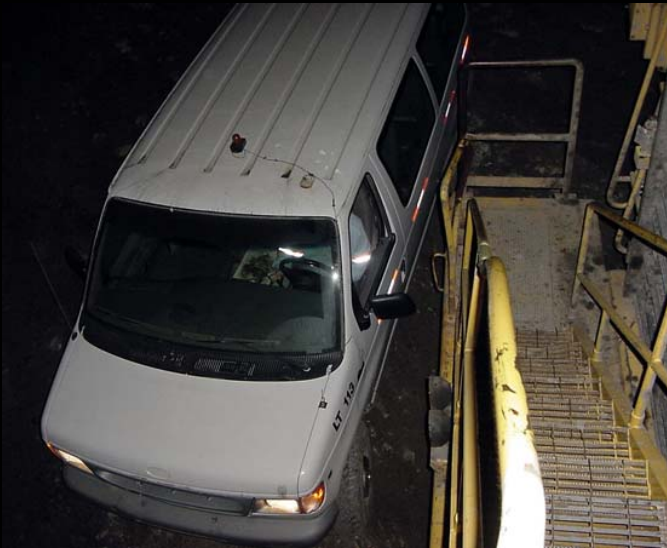
- The rock truck driver following the van stopped his rock truck ~300' behind the parked rock truck and he started cleaning the interior of his truck.
- The van driver intended for the rock truck driver to climb down from the cab to meet him. To facilitate transfer of supplies, he parked the van in front of the rock truck bumper, with the driver-side door of the van aligned with the access ladder on the off-side of the truck.
- The rock truck driver was leaning down, getting ear plugs out of his dinner bucket, and did not see the headlights on the approaching portal van when he heard the radio transmission.
